Assignment

We Buy Cars

Vehicle Type	PASSENGER VEHICLE	Registration Number	6A4110422
Manufacturer	MERCEDES BENZ		
Model	SLK 350	Paint Finish	M - METALLIC
VIN	WDD1724572F067978	Fuel	PETROL
Year Model	2013	Transmission	AUTOMATIC
Km Reading	69,332 KM	Doors	2
Cab / Body Type	COUPE	Color	WHITE

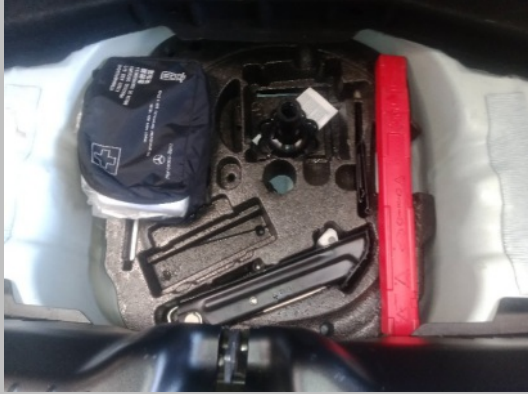
No spare wheel

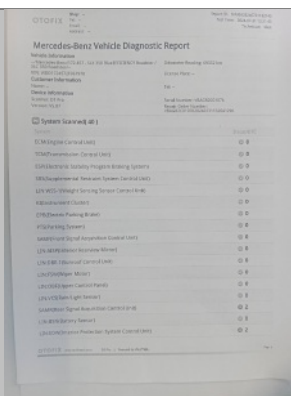
Diagnostic test

No	System	Code	Description	Status
1	LIN:EDW	U114000	COMMUNICATION WITH THE TOW-AWAY PROTECTION SENSOR	ACTIVE

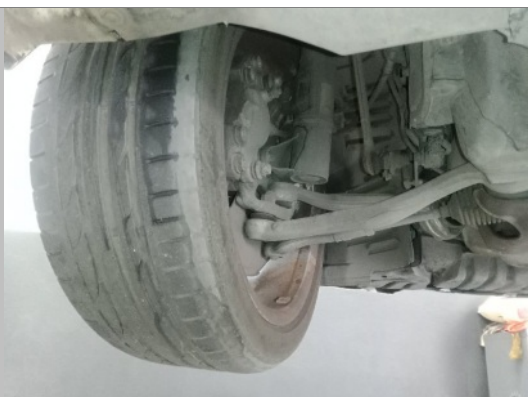
LF TYRE TREAD

Size	Load/Speed Index	Manufacture	Model	Type*	Production Date	Tread Depth (mm)
Front Left	225/40R18	92Y	Bridgestone	Potenza	V	5021	0 mm
Front Right	225/40R18	92Y	Bridgestone	Potenza	V	5021	0 mm
Rear Left	245/35R18	92Y	Bridgestone	Potenza	V	0414	0 mm
Rear Right	145/70R17	92P	Vredestein	Space master	V	0218	1 mm

Damage	Repair Way
Tyre Rear Left Smooth	Roadworthy Relevant
Different tyre size and profile on rear axle	Roadworthy relevant
Both front tyres smooth	Roadworthy relevant
